# PUBLIC ROADS

A BITUMINOUS SURFACE TREATMENT OF A LIME ROCK ROAD IN FLORIDA

Page
An Investigation of Oil-Treated Roads in Missouri . . . . .	49
The Action of Sulphate Water on Concrete . . . . .	64
Gasoline Taxes, 1930 . . . . .	86

In anticipation of this demand for low-cost roads, the Missouri State Highway Department, in cooperation with the United States Bureau of Public Roads and the United States Bureau of Chemistry and Soils, has been investigating the practicability of oil-treated roads, with or without subsequent stages of improvement, for use in those sections, comprising approximately one-third of the total area of the State, where no surfacing material of any kind is locally available. The collecting and organization of the data and observations on application of the oil and the condition surveys on the sections studied and included in this report were carried out by R. C. Schappler and C. M. Lancaster, of the division of geology and soils of the Missouri State Highway Department.

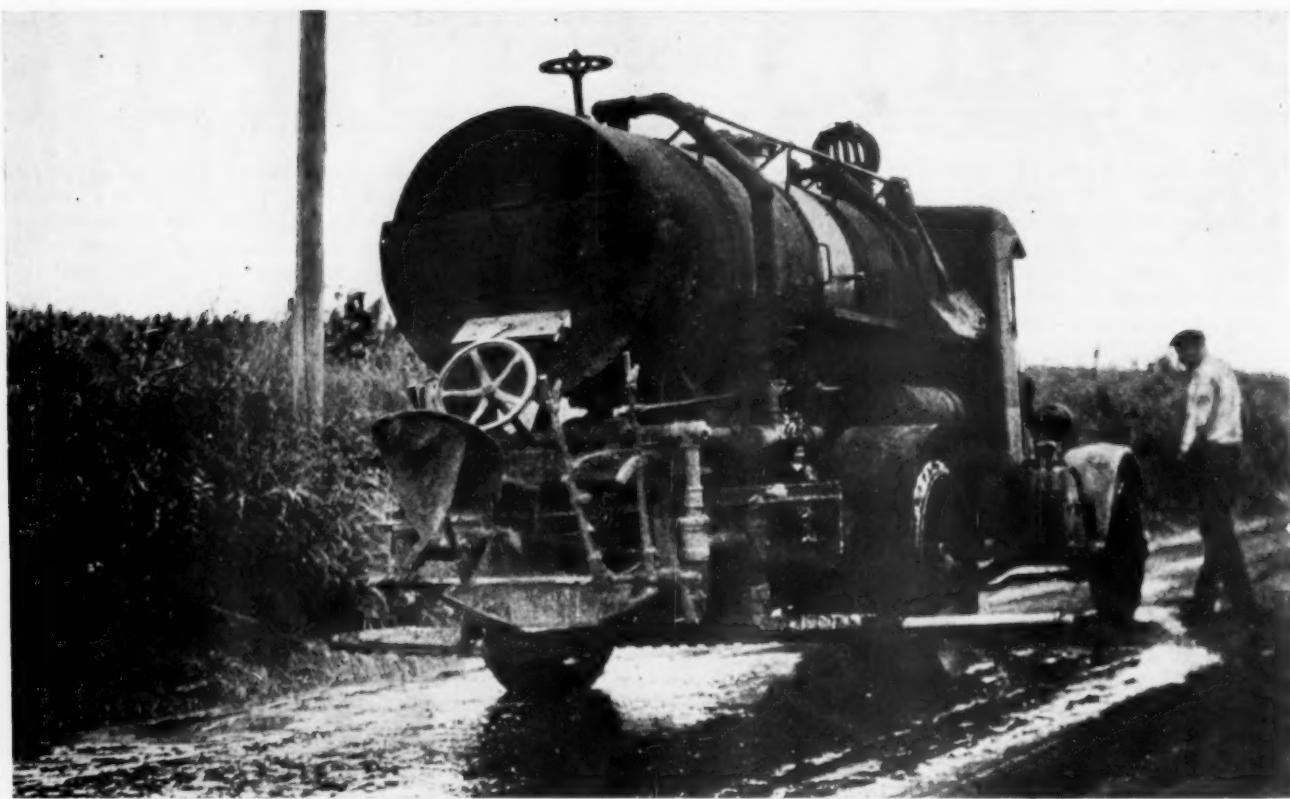
FIGURE 1.—EIGHT HUNDRED GALLON PRESSURE DISTRIBUTOR READY TO BEGIN APPLICATION. OVERLAPPING OCCURRED IN APPLYING SUCCESSIVE LOADS

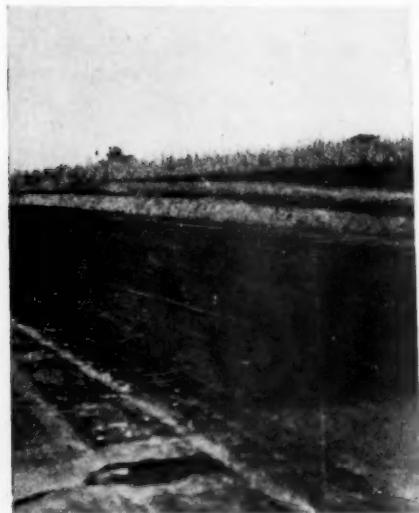
MAT INTACT, SURFACE SMOOTH

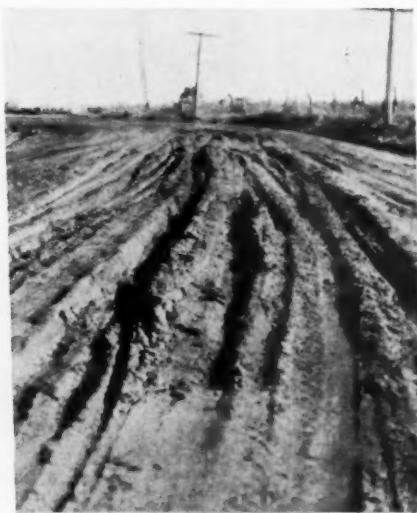
*Surface rutted.*—This term indicates the presence of indentations or grooves in the road surface. Rutting occurs when the subgrade is softened because of the presence of moisture. It is generally preceded by a decrease in the stability of the supporting soil, which can usually be traced to moisture furnished by rains or melting snow occurring on top of the road, by seepage or capillarity beneath, or by a combination of both.

SURFACE DEEPLY RUTTED

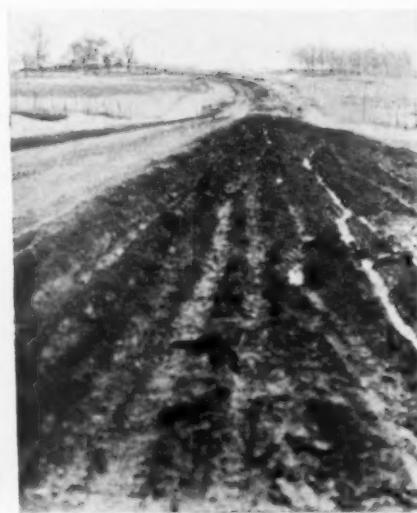
SURFACE RUTTED

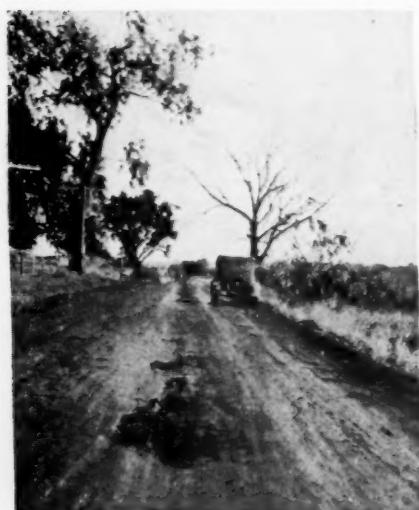
*Mat crumbled.*—This term indicates a crumbling of the oil-earth mat caused either by an insufficient amount of oil or by a deadening of the oil fraction. This term is not used when failure can in any way be traced to a decrease in the stability of the supporting soil. Thus, crumbling is entirely a surface defect and indicates that the applied bituminous material either has not properly penetrated the soil or does not possess cohesion in amount sufficient to bind the soil particles into a compact mat.

MAT CRUMBED

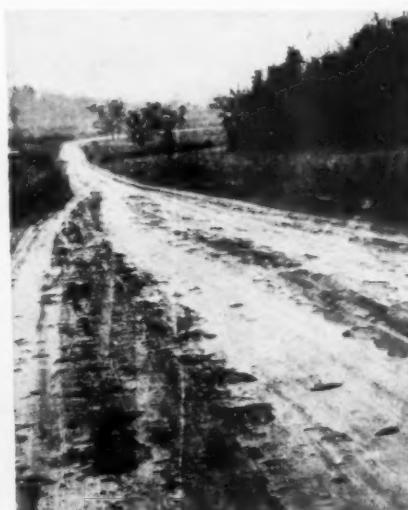
*Mat raveled.*—This term indicates a progressive breaking up, but not a crumbling of the mat. It generally occurs after periods of alternate freezing and thawing and suggests vertical displacement of the mat. This vertical displacement may be produced by expansion of the subgrade due either to increase in moisture content or to freezing followed by shrinkage of the subgrade caused by reduction in moisture content or thaw, thus leaving the mat suspended without support. Nonuniform subgrade soil is especially productive of raveling.

SURFACE PITTED AND RAVELED

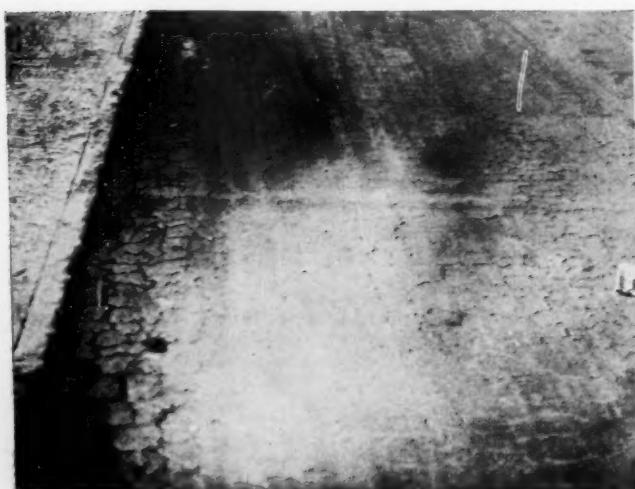
*Surface checked.*—This term indicates the occurrence of shrinkage of the surface soil disclosed by "alligator

SURFACE CHECKED

hide" cracking which separates the oil-earth mat into irregularly shaped blocks.

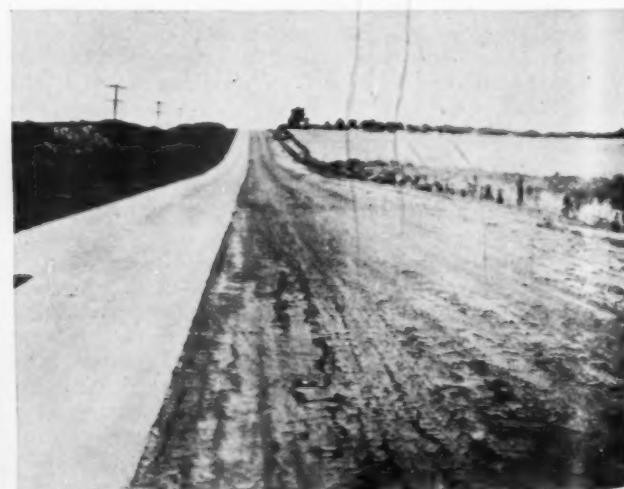
SURFACE SCALED

*Surface sealed.*—This term signifies the sealing off of the oil-earth mat in thin layers. Scaling is caused generally by a laminated or plated structure existing in the oil-earth mat.

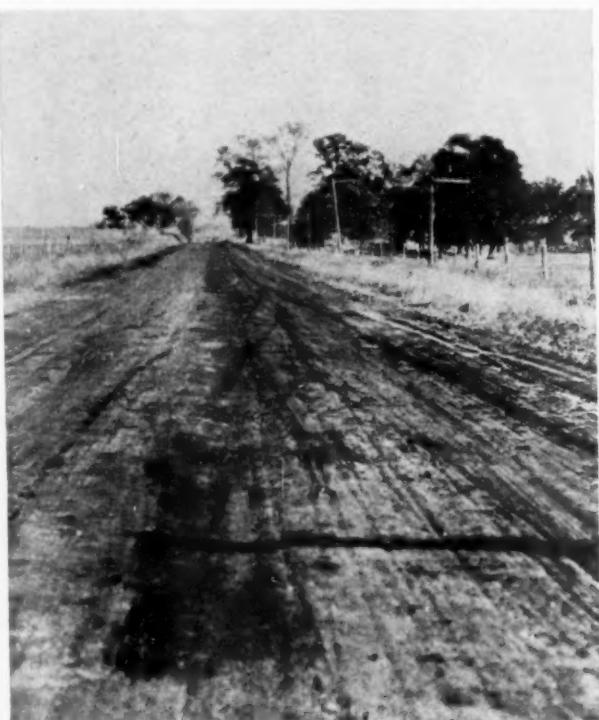
FIGURE 4.—POORLY DRAINED SECTION. THE IRREGULAR SURFACE HAS CAUSED TRAFFIC TO FOLLOW SELECTIVE TRAFFIC LANES. AS A RESULT PORTIONS OF THE SURFACE HAVE BEEN DEPRIVED OF THE IRONING AND KNEADING EFFECT OF TRAFFIC AND HAVE RAVELED EXTENSIVELY

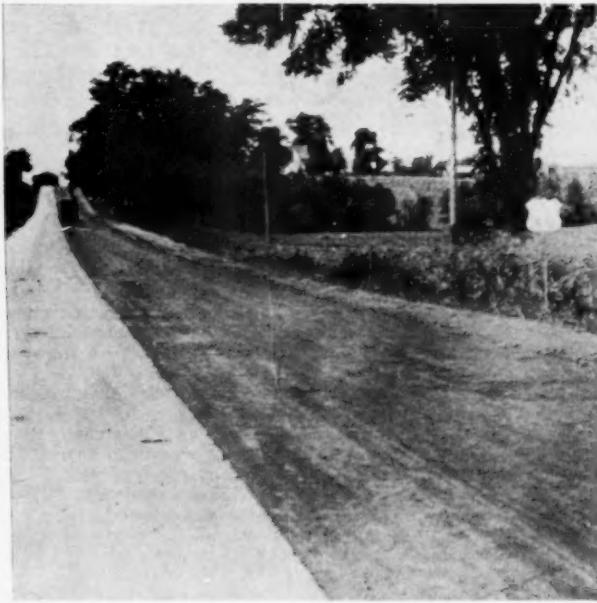
FIGURE 5.—SECTION IN GOOD CONDITION THREE MONTHS AFTER TREATMENT. THE SURFACE CONTAINED AN APPRECIABLE AMOUNT OF MOISTURE WHEN OIL WAS APPLIED.

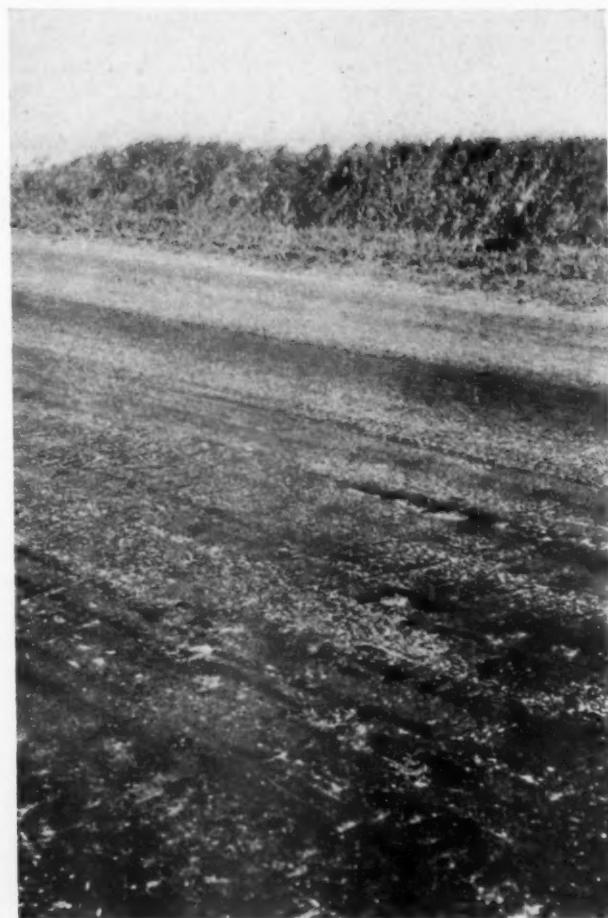
one section not showing the presence of moisture was rated as poor at the time of the second condition survey. All sections rated as poor or failed, had no appreciable amount of moisture at the time of application of the oil.

FIGURE 6.—SURFACE WAS PARTLY CRUSTED AND HARDENED AT THE TIME OIL WAS APPLIED. SHRINKAGE CRACKS ARE NUMEROUS AND PITTING IS EVIDENT

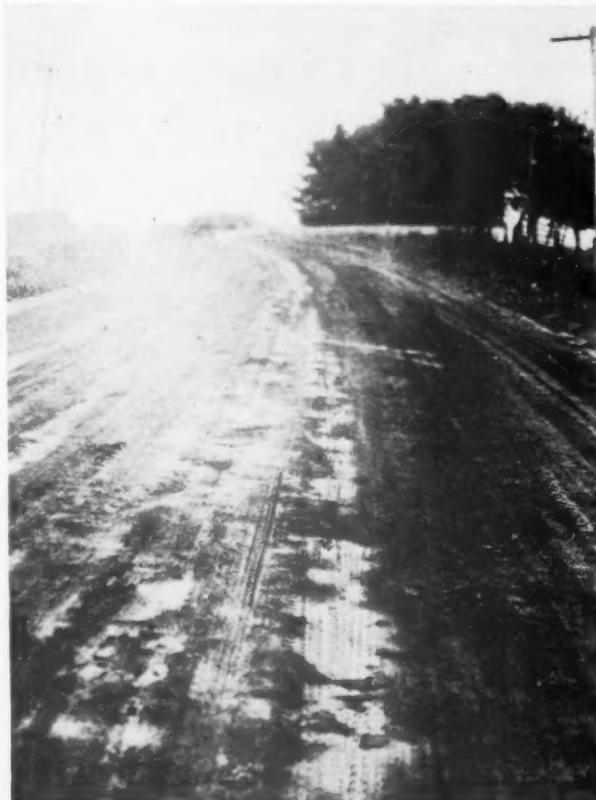
FIGURE 7.—APPEARANCE OF SURFACE AFTER FIRST APPLICATION OF OIL. NONUNIFORM PENETRATION HAS OCCURRED BECAUSE OF LOOSE MATERIAL ON THE SURFACE. THE PRESENCE OF UNABSORBED OIL ON THE SURFACE IS INDICATED BY THE LIGHT SPOTS

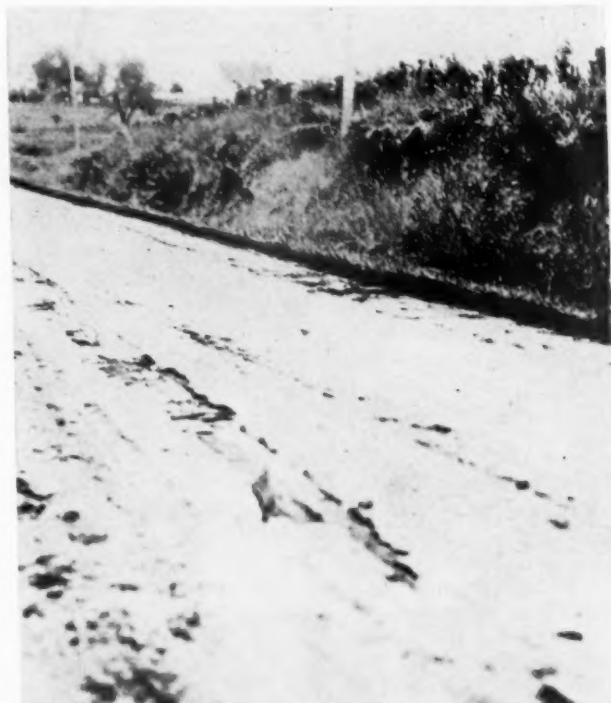
by the hoofs of cattle and horses. Any reasonable and practical means of mitigating the effects of mutilative traffic will justify some expenditure. As stated previously, in some cases cover material, generally river sand, was applied in a thin layer to the surface. The results seemed to be uniformly beneficial except in the presence of conditions causing the failure of the oil treatment.

FIGURE 8.—MUTILATING EFFECT OF TRAFFIC AFTER RETREATMENT
